GROUNDWATER ELEVATIONS
08/12/03

FIGURE 2

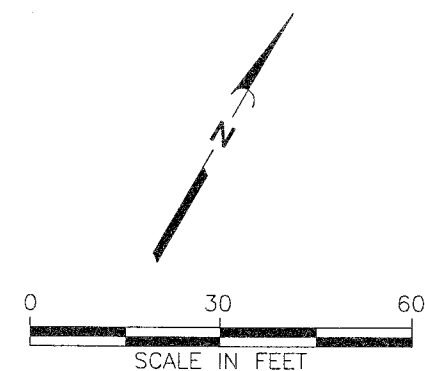
MW-2 ● MONITORING WELL
4.98 GROUNDWATER ELEVATION (IN FEET)

➤ APPROXIMATE GROUNDWATER
FLOW DIRECTION

--- JUNE-JULY 2002 EXCAVATION LIMITS
